Troubleshooting for DI16, DI1500, DI110 & DI150

DI Series Piston “Fit” Test

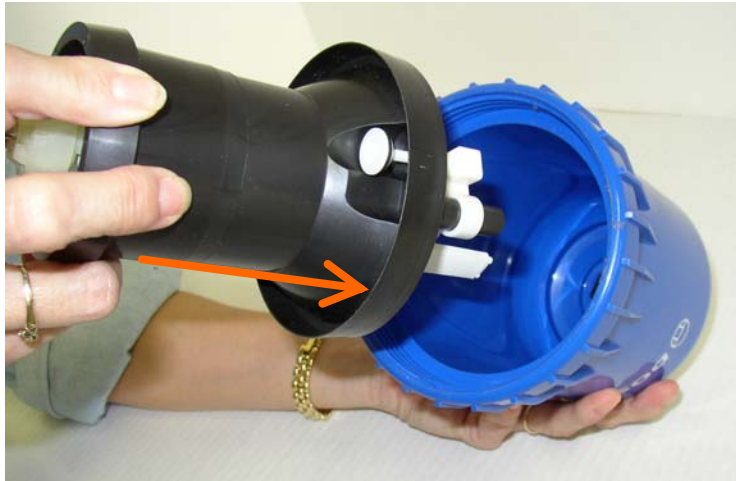
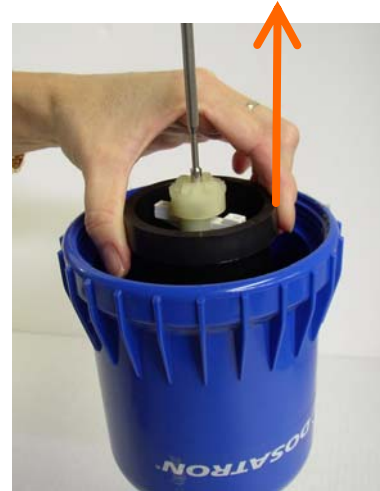
Insert upper portion of piston into the bell housing half way down, turn the bell housing upside down and hold the smaller part of the piston ONLY, then lift it. The piston should be snug in the bell housing and the bell housing should not fall off, if it does the upper piston shell needs to be replaced. Also, inspect the inside of the bell housing and look for deep vertical scratches. If this is the case, the bell housing needs to be replaced.

Note: It is best to remove the plunger (except for DI1500) prior to doing this test so it will not interfere.

The plunger is the part screwed onto the metal rod located at the bottom of the piston.

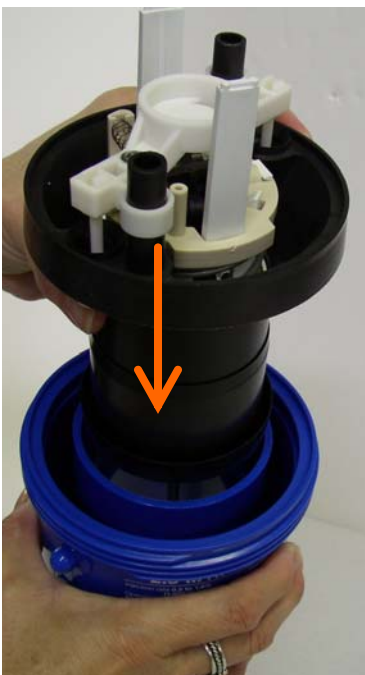
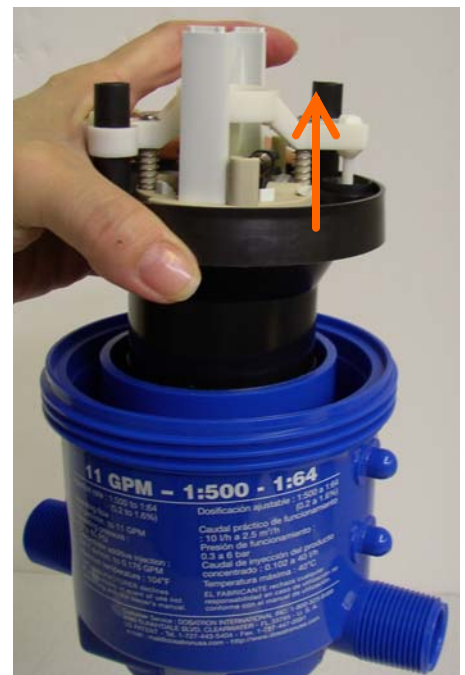
Insert the lower part of the piston half way down the body. Holding onto the top of the piston, let go of the body. The piston should be snug in the body, and the body should not fall off, if it does the lower piston shell needs to be replaced.

Also inspect the inside of the body and look for deep vertical scratches. If this is the case, the body needs to be replaced.

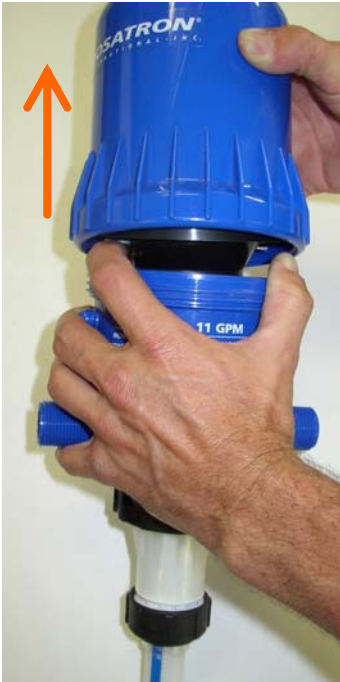
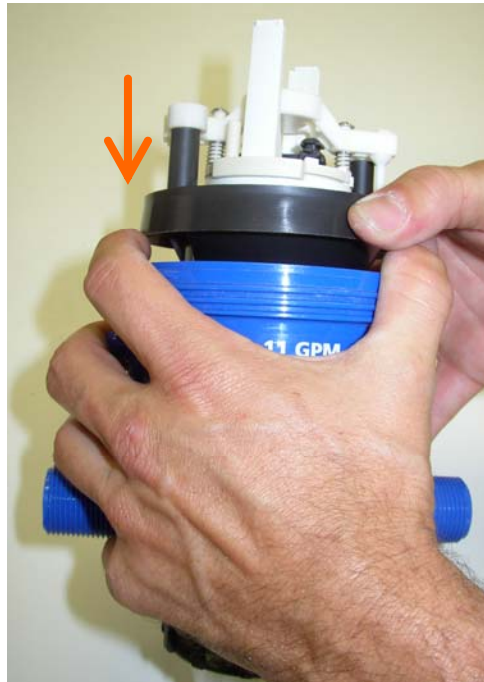
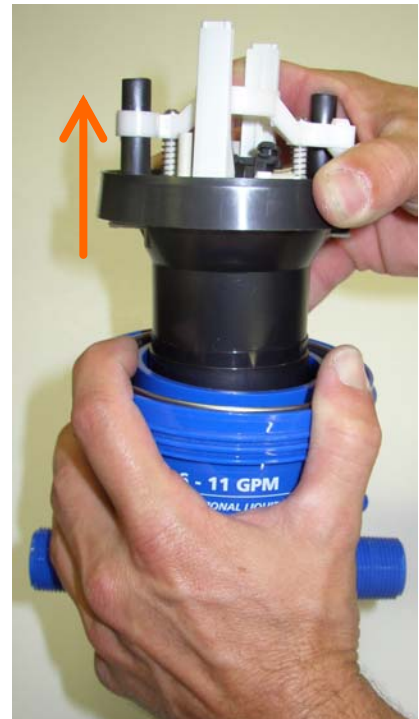
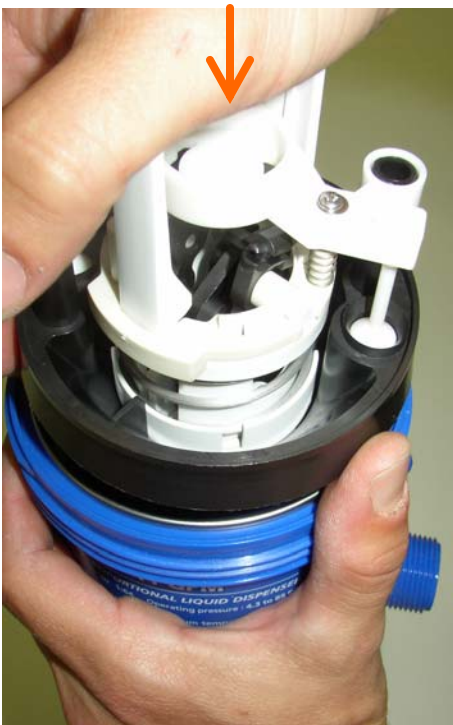
Reset DI Series Piston

To reset the piston, remove the bell housing, push the piston all the way down, it may click, pull the piston all the way up. Holding it in up position, push down on the vertical posts it should click. Push the piston back down, it should click once more, and screw the bell housing on.
